RESOURCE # TAC-299

1. NAME OF RESOURCE (how determined):  
4 / Original or later significant uses of the property  
Central Kentucky Motor Lodge

2. ADDRESS/LOCATION:  
221 W. Main Street  
Campbellsville, KY 42718

10. REPORT/NR REFERENCE:  
Campbellsville Historic Commercial District

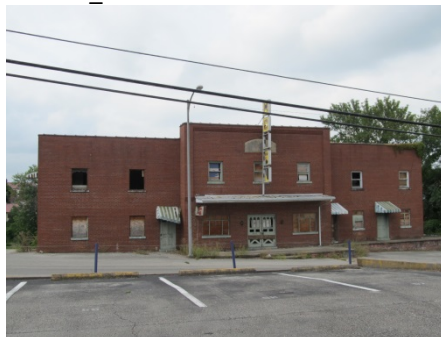
TAC299\_01

The motel occupied the top two floors. The bottom floor was occupied by Creekside Restaurant. A fire destroyed the restaurant and part of the interior of the motel.
