1. NAME OF RESOURCE (how determined):
4 / Original or later significant uses of the property
Commercial Building; Artesanias Angel Pottery

2. ADDRESS/LOCATION:
126 E. Main Street
Campbellsville, KY 42718

10. REPORT/NR REFERENCE:
Campbellsville Historic Commercial District

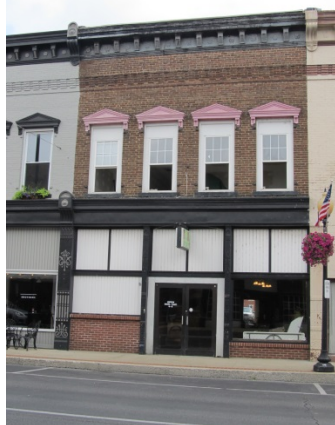
TAC42_01

14. DATE OF MAJOR ADDITIONS/MODIFICATIONS (specify):
1: 1975-2000: 1997 enclosed storefront & transom
windows
A: 2001-Present 2008 replaced second floor
windows

22. CONDITION:
F / Fair-under maintained

23. MODIFICATION: 2 / Moderate alteration

26. WINDOWS: Original Replacement
Type: Vinyl
