(KHC 2011-1)

RESOURCE # TAC-13

1.	NAME OF RESOURCE (how determined):	17. PLAN:
	4 / Original or later significant uses of the property	First: U / Undetermined/not applicable
	Pank of Comphallevilla	Second:
	Bank of Campbellsville ADDRESS/LOCATION:	18. STYLISTIC INFLUENCE:
۷.	111 East Main Street	First: 4:2: Italianate
	Campbellsville, KY 42718	Second:

Bank of Campbellsville (TAC-13)

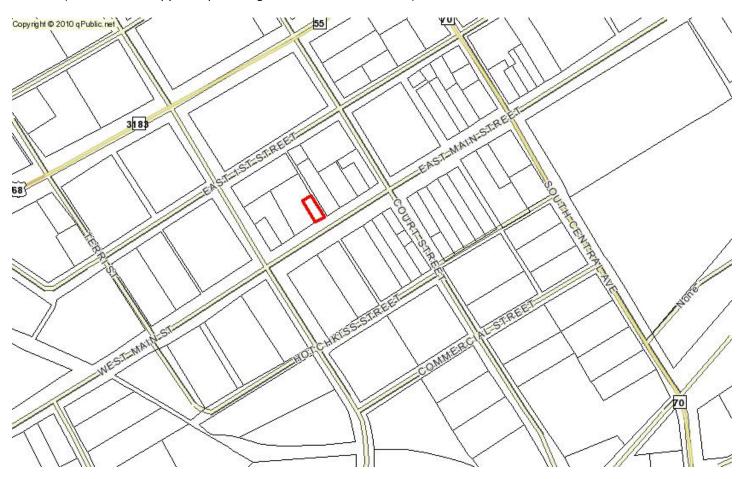
This three-bay, two-story brick structure is constructed of common bond brick. The stone front on the first floor is pierced by the main arched windows that are accented with keystone. The second floor windows have stone sills and are highlighted with segmental brick arches. A tin cornice is accented with brackets that are decorated with acanthus leaves. The words "BANK OF CAMPBELLSVILLE" appear in its façade.
