(KHC 2011-1)

1. NAME OF RESOURCE (how determined):
4 / Original or later significant uses of the property
Taylor National Bank Building; Citizens Bank and Trust

2. ADDRESS/LOCATION:
201-217 East Main Street
Campbellsville, KY 42718

10. REPORT/NR REFERENCE:
Campbellsville Historic Commercial District

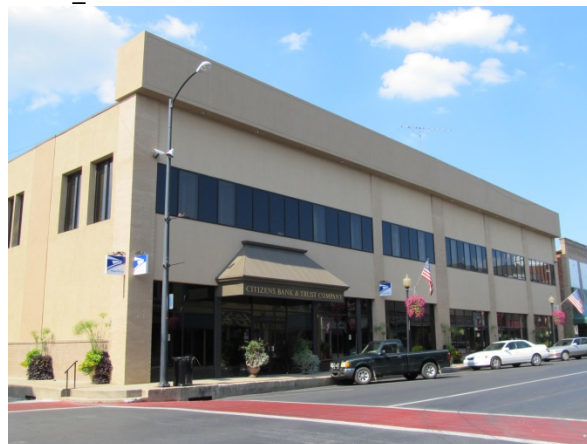
TAC20_01

Originally, this building was four stories tall until a fire destroyed the top floors. This two-story Bedford stone and New Hampshire granite building was covered with stucco panels in recent years. In 1924, about the middle of the block was Sam and Sodas, a confectionery. Later, 203 was Moberly Grocery, then Hobbs 5 & 10. 205 was Bob Chandler Drug Store, Kroger Grocery, then Taylor County Supply. 207 was Henry Wilkerson Shoe Store, D.L. McCubbins Pool Room, then Brack's Variety.
